**Evaluation of Corrosion Resistance of New and Upcoming Post-Tensioning  
Materials After Long-Term Exposure Testing**

**Thesis**

The University of Texas at Austin

**December 2010**

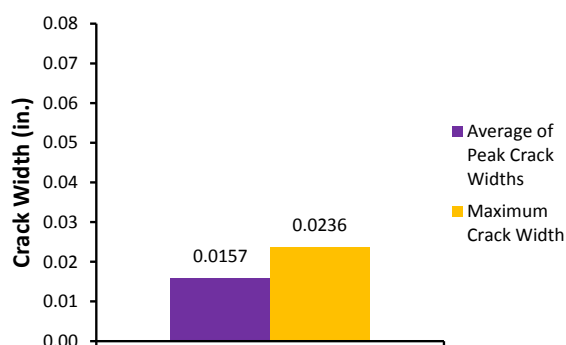
**Figure 5.76: Specimen 3.2 Crack Data**

Three primary transverse cracks crossed the top face of the specimen and extended down its sides. The side face portions of the cracks had been sealed with epoxy, which was intact at the time of autopsy. The average width of these cracks was 0.015 inches. Several longitudinal cracks extended along various portions of the top surface. These were mostly located above the specimen's ducts. Average width of the longitudinal cracks was 0.004 inches. Cracks were found extending from the live end anchorage pourback to near the re-entrant corner of the live end corbel on both faces of the specimen. A short distance of these cracks had been patched with mortar, but most of their length was not patched. This suggests that the cracks expanded some time after live load application. Efflorescence was observed at points along these cracks, suggesting the presence of moisture inside the specimen (see Figure 5.74). Crack width data is shown in Figure 5.76, and the crack diagram is shown in Figure 5.80.

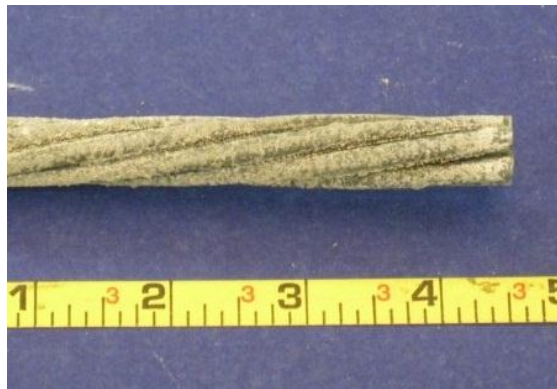
Similar to Specimen 2.2, the galvanized strand in this specimen was observed to have a much stronger bond with the surrounding grout than other types of strand. In addition, small bubbles were observed in the interstices of several strands, most prominently within a few inches of the end of the strands, as shown in Figure 5.78. This may be a sign that a chemical reaction occurred between the strands' zinc coating and the surrounding grout.

*Figure 5.78: Specimen 3.2, Bubbles in Interstices of Galvanized Strand*

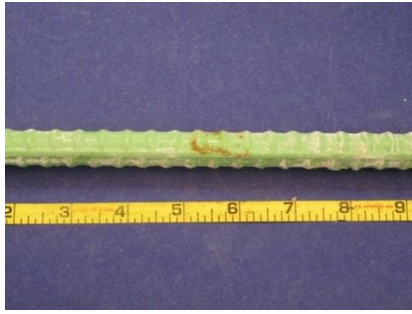
**Longitudinal Bar**

Both longitudinal bars experienced very minor corrosion damage. The bars showed localized discoloration and light surface corrosion, occurring mostly at locations where stirrups had been tied (see Figure 5.79). Neither bar experienced any non-removable corrosion in any interval. The highest corrosion ratings occurred beneath the transverse surface crack nearest the live end of the autopsy region. Longitudinal bar corrosion ratings are shown in Figure 5.80 and summarized in Table 5.17.

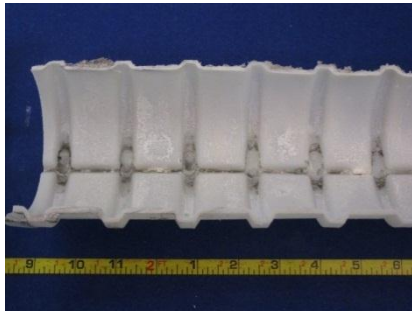
**Top of North Duct**

The exterior of the north duct was covered in chalky white residue. Some localized, dull corrosion staining was visible, as well. The top interior portion of the duct showed evidence of small voids which had formed within the top ribs of the duct. These voids appeared slightly larger on the live end half of the duct than on the dead end half. Traces of shiny white crystals were found around the upper ribs in the duct's interior, as well as intermittently on the lower region (see Figure 5.79). Light scratches were observed near midspan and near both ends of the duct on its bottom portion. This indicates that the duct was slightly damaged by the strand as it was passed through prior to stressing.

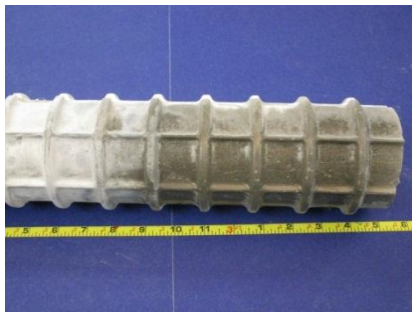
**North Grout**

The north tendon grout had transverse cracks every few inches along its length. No longitudinal cracks were found. Small voids, approximately 0.75 inches across, were found on the top surface of the grout. These voids were continuous over each half of the duct due to the duct's top longitudinal rib. The voids were slightly larger on the live end half of the grout than on the dead end half. The surface of all voids was uniformly dark gray in color. The end regions of the grout were much darker in color than the middle region, as shown in Figure 5.79. This indicates that segregation took place during or after grouting. The grout as a whole was very difficult to crack open, and its entire surface was very smooth to the touch. These observations suggest that the grout was very well consolidated. Segments of strand were visible along the bottom of the grout over much of its length. Chloride content at midspan of the grout was 0.48%.

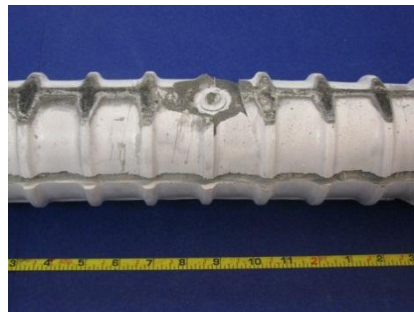
**South Grout**

The south tendon grout showed transverse cracks, but these cracks were only visible every few inches near midspan of the grout. Voids were observed in the top portion of the grout.

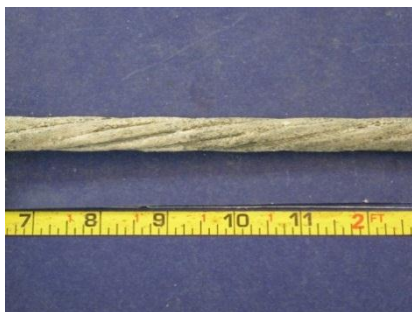
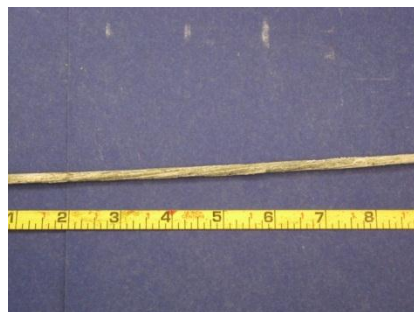
The north tendon strands were only slightly damaged. Small, isolated flecks of light corrosion or discoloration were found on one or more outer wires on some intervals, although the outer wires showed no damage at all on many intervals. The inner wires were slightly more damaged. However, all corrosion flecks were able to be scrubbed away with a scouring pad. Corrosion was most severe for the north duct strands in the region near midspan. Corrosion ratings were generally uniform along the entire length of the tendon.

The south tendon strands showed similar damage to that of the north strands. Some isolated flecks of corrosion were found on the strands' outer wires in a few intervals. Otherwise, the outer wires showed either discoloration or no damage at all. Again, the inner wires were more damaged, showing light surface corrosion spots in more intervals than the outer wires. All

corrosion spots could be removed with a scouring pad. Overall, the south duct strands were somewhat more damaged than the north duct strands. Corrosion ratings for the south duct strand were higher near the live end of the autopsy region than the dead end. A typical strand and inner wire are shown in Figure 5.79. Strand corrosion ratings are shown in Figure 5.80 and summarized in Table 5.17.

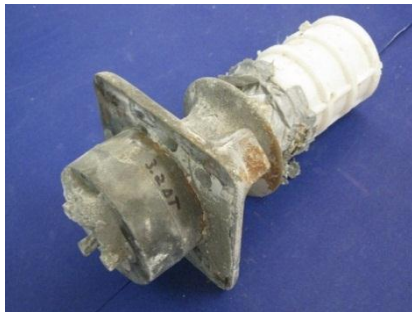
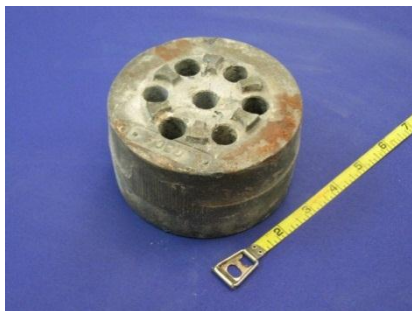
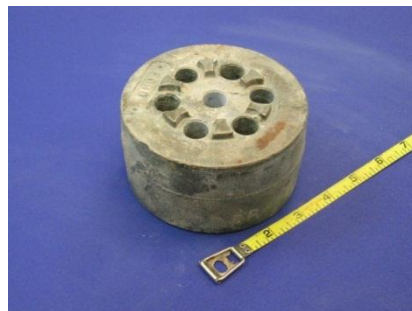
***Figure 5.81: Specimen 3.2 Dead End Anchorages and Anchor Heads***

The epoxy used to seal the exposed surfaces of both dead end anchorages was mostly intact on the bearing plates and mostly missing on the anchor heads. Both bearing plates showed only localized light to moderate corrosion over a small portion of their exposed area. Corrosion was much more widespread on the underside and along the lower interior edges of the bearing plates. Some localized discoloration was also found on the top and side surfaces. The duct tape used to splice the ducts to the anchorages was mostly intact at the time of autopsy. Some light corrosion was found on the north anchorage on the areas which had been covered by duct tape. The corrosion in this area was more severe on the south anchorage. Large patches of moderate corrosion were found on the inboard surface of the north anchor head, as well as light discoloration on its other surfaces. Only one small spot of corrosion was observed on the interior side of the south anchor head. The level of discoloration on the other surfaces was comparable to the north anchor head. The north and south anchorages and anchor heads are shown in Figure 5.81.

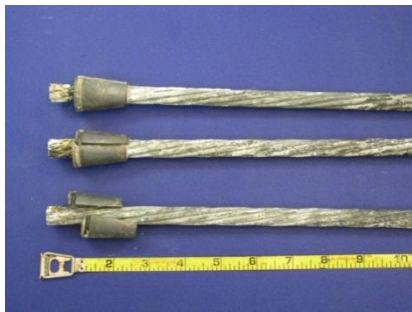
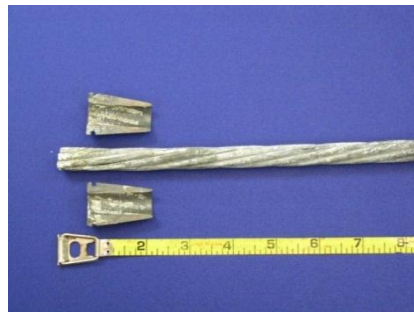
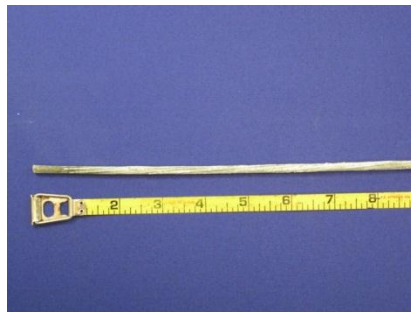
The dead end anchorage zone strands experienced localized discoloration and light surface corrosion along their entire lengths. The outer wires in all strands showed discoloration and flecks of corrosion which could be removed with a scouring pad over many intervals. Damage was the worst at the exposed strand ends and in the region where the wedges were located. The inner wire on each strand was typically more extensively corroded or discolored near the wedge region than the outer wires. Inner wire damage further into the specimen was comparable to that of the outer wires. All wedges were found to be intact with only light localized corrosion or discoloration on their outer surfaces. Typical strands, with and without wedges, are shown in Figure 5.82. Dead end anchorage zone strand corrosion ratings are shown in Figure 5.85 and summarized in Table 5.18.

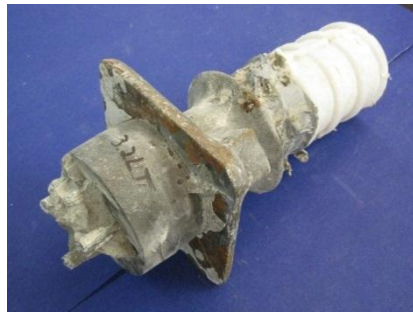
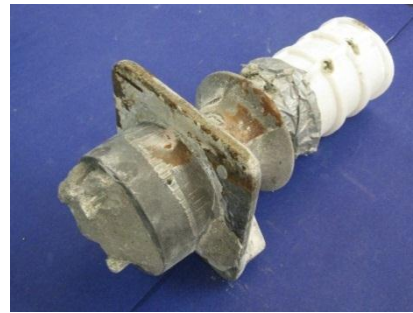
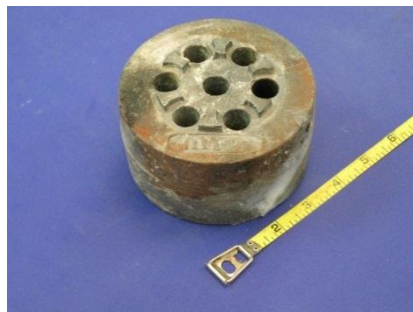
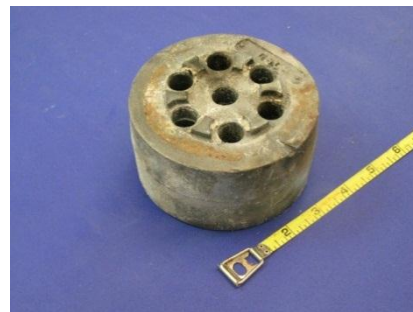
**Figure 5.83: Specimen 3.2 Live End Anchorages and Anchor Heads**

Most of the epoxy on the exposed surfaces of the live end anchorages was gone. The south bearing plate experienced light corrosion on some of its exposed surface, while the north bearing plate had moderate corrosion over the majority of its exposed area. The north and south bearing plates were moderately corroded on their bottom surfaces and on all inside edges of the bearing plates. This damage was more severe on the north anchorage than the south anchorage. Although the duct tape splices were mostly intact on both anchorages, there was extensive moderate corrosion and some pitting found underneath the duct tape. The north anchor head experienced widespread moderate corrosion on its inner surface and lighter localized corrosion on much of its other surfaces. The south anchor head was much less damaged, with light to moderate localized corrosion on its inside surface and extremely localized light corrosion or discoloration elsewhere. The north and south anchorages and anchor heads are shown in Figure 5.83.

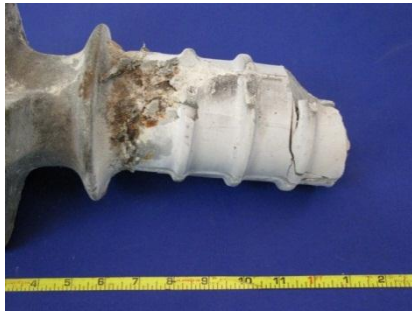
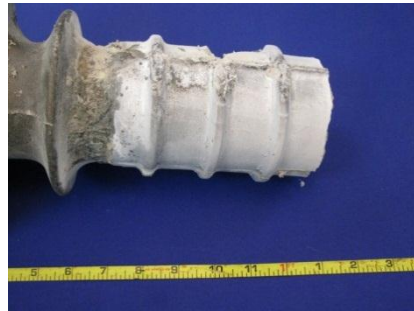
Both north and south tendon grouts showed evidence of voids on their top surfaces. These voids appeared to be connected by the top longitudinal rib of the surrounding duct. Both grouts were extremely smooth to the touch. However, some variation in color on the grouts' surface suggests that segregation may have been an issue. The north grout was heavily stained near its interface with the bearing plate. Neither grout appeared to be cracked at the time of autopsy. North and south grouts are shown in Figure 5.84.

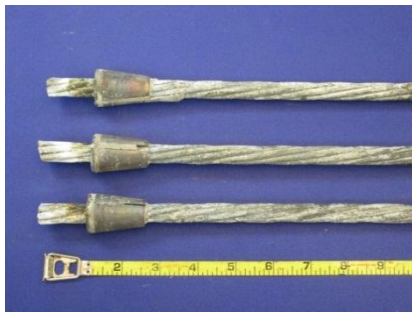
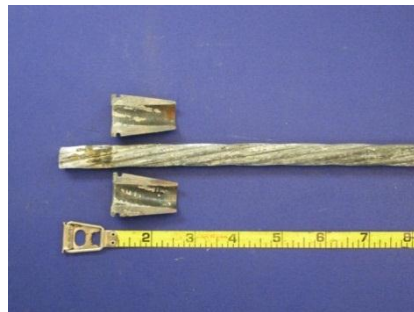
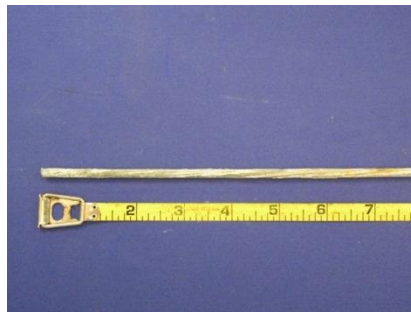
Damage to the live end anchorage zone strands was light to moderate. The outer wires of all strands showed some discoloration and localized light corrosion in most intervals. The inner wires showed similar damage, although corrosion was somewhat more widespread in the inner wires. Spots of corrosion which could not be scrubbed away were found on the inner wires of two of the north duct strands. Overall, corrosion ratings were highest where the strands had been exposed and where they had been inside the anchor heads. All wedges were intact, showing only localized light corrosion and discoloration. Most of this damage was observed on the outer surfaces of the wedges. Typical strands, with and without wedges, are shown in Figure 5.84. Live end anchorage zone strand corrosion ratings are shown in Figure 5.85 and summarized in Table 5.18.

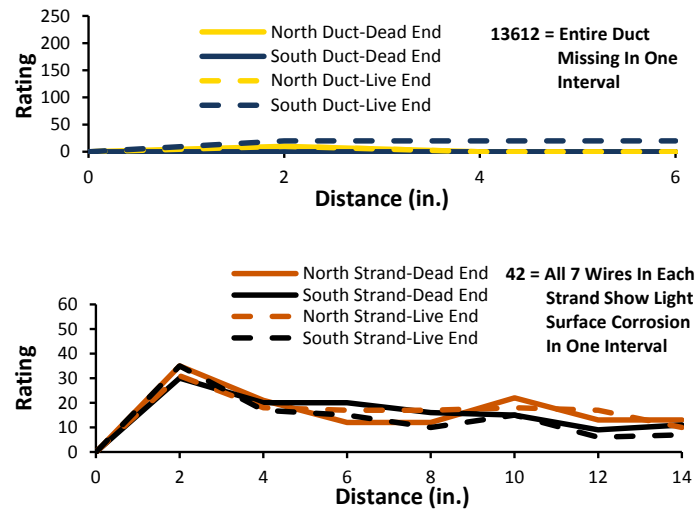
**Figure 5.85: Specimen 3.2 Live and Dead End Anchorage Corrosion/Damage Ratings**

The live end bearing plates and anchor heads appeared marginally more corroded than their dead end counterparts. Damage to the anchorage zone ducts was more severe at the live end than at the dead end. However, this is inconsequential because the damage was not caused by corrosion, nor was it severe enough to allow chloride ingress into the tendon. Damage to the strands was comparable in both anchorage regions. The strand corrosion rating plots are nearly identical for the live and dead end strands. No clear correlation between exposure and corrosion can be seen. These factors suggest that chlorides did not enter the specimen at its dead end, perhaps due to the absence of any large cracks on the specimen's dead end face. Again, it should be noted that the dripper system had not been operational for at least one year before autopsy.

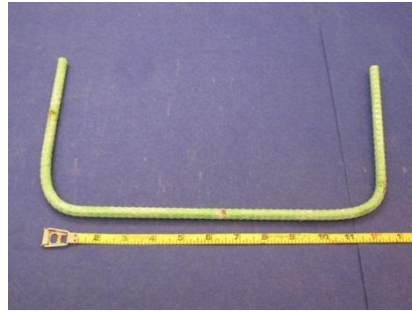
**Stirrup**

Corrosion observed in the stirrups was similarly mild. Light corrosion and discoloration was observed at the stirrups' bend points and along their horizontal portions, as shown in Figure 5.91. Moderate corrosion was seen on only two stirrups. Otherwise, all observed corrosion could be scoured away. Corrosion ratings showed little variation along the length of the autopsy region, although the five middle stirrups' ratings were slightly higher. Stirrup corrosion ratings are shown in Figure 5.92 and summarized in Table 5.19.

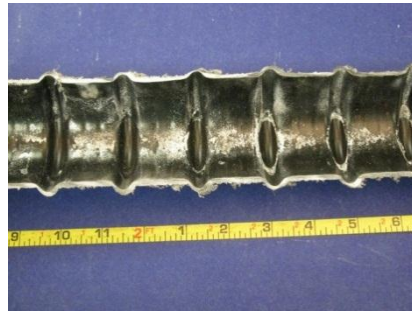
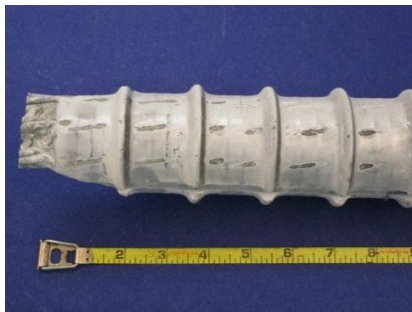
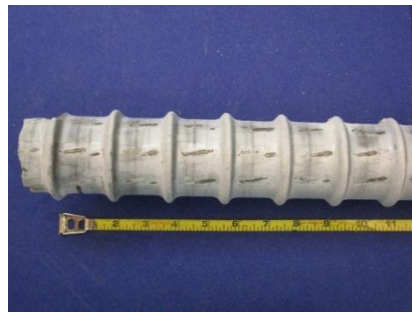
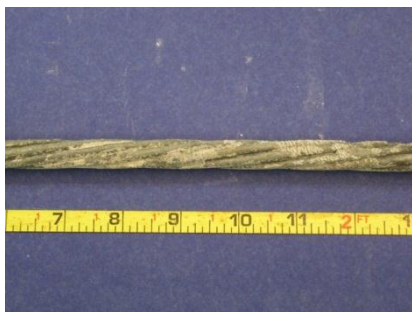
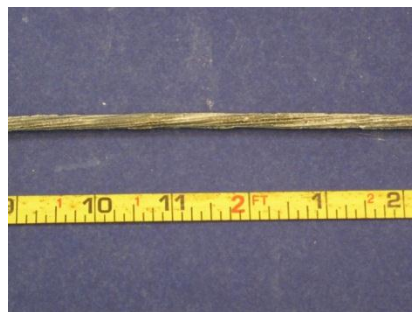
**Figure 5.91: Specimen 3.4 Main Autopsy Region Elements**

As with previous specimens containing hot-dip galvanized strand, the strands in this specimen were observed to have a very strong bond with the surrounding grout. Also, some small bubbles were found in the strands' interstitial grout, suggesting that a chemical reaction may have occurred.

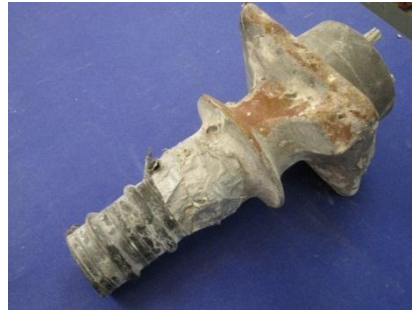
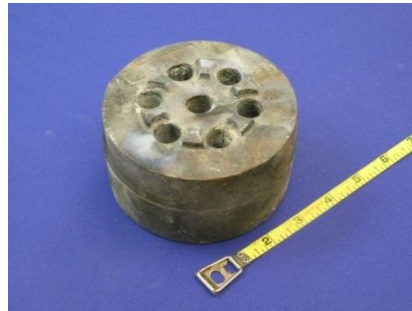
***Figure 5.93: Specimen 3.4 Anchorages and Anchor Heads***

The epoxy used to seal the exposed surfaces of the anchorages prior to applying the pourback were partially intact on the bearing plate and completely gone on the anchor head. The north bearing plate showed some very localized light surface corrosion, mostly on its lower half. Isolated light to moderate surface corrosion was found on the underside of the north bearing plate, mostly occurring near the grout vent located there. Some pitting was observed on the lower, inside edge of the bearing plate. The south bearing plate was more extensively corroded, with moderate surface corrosion occurring on most of its lower half. Moderate surface corrosion and some pitting were observed around the inside edges of the bearing plate, as well. The duct tape used to seal both bearing plates to their ducts was intact, with some light to moderate corrosion occurring on the anchorage surfaces beneath. The north anchor head showed only light surface corrosion on its side surface near the bearing plate, with faint discoloration occurring on other surfaces. The south anchor head was similar in appearance. However, the corrosion was less prominent and the discoloration more widespread. North and south anchorages and anchor heads are shown in Figure 5.93.

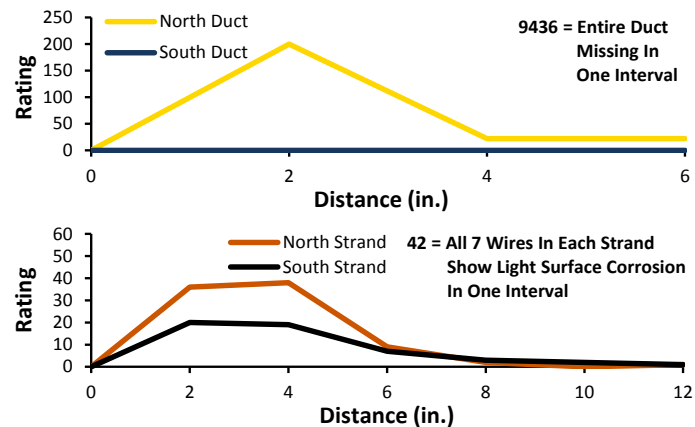
**Figure 5.94: Specimen 3.4 Anchorage Zone Corrosion/Damage Ratings**

The outside surface of both ducts showed the same chalky white residue which was found on the ducts in the main autopsy region. Large deposits of cement paste were found in the splice region of both ducts. This occurred because the ducts are slightly smaller than the anchorage opening, which allowed paste to enter and adhere to the ducts. On their inner surface, both ducts also contained traces of a shiny white residue. Evidence of voids was found on the top inner portion of both ducts. These voids appeared to be contained within the ribs of the ducts. The north duct experienced light gouging, mostly near the duct's joint with the anchorage. No gouging was observed in the south duct. North and south ducts are shown in Figure 5.95. Anchorage zone corrosion ratings are shown in Figure 5.94 and summarized in Table 5.20.

The anchorage zone strands in both tendons showed similar levels of corrosion. Small flecks of light surface corrosion and discoloration were observed over the entire length of strand, generally on more than one wire per interval. Outer wire damage was greatest in the region which had been inside the wedges. Inner wire damage was uniform, with discoloration and light surface corrosion spots found along the entire length of wire on every strand. All wedges were physically intact, showing only mild surface corrosion on their outer surfaces and isolated spots of discoloration inside. Typical strands, with and without wedges, are shown in Figure 5.95. Anchorage zone strand corrosion ratings are shown in Figure 5.94 and summarized in Table 5.20.

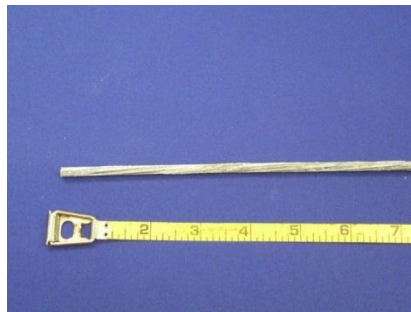
**Figure 5.95: Specimen 3.4 Anchorage Region Elements**

The south tendon grout was severely damaged during extraction, so no meaningful observations could be made. The north tendon grout showed signs of small voids on its top surface and a long void within the anchorage itself. Over the region which had been covered by the north duct, the grout appeared to be well consolidated. The grout in this region was very dark and very hard to break. Two strands were visible on the grout's bottom surface over the entire

duct region. The grout was not observed to be cracked. North and south tendon grouts are shown in Figure 5.95.

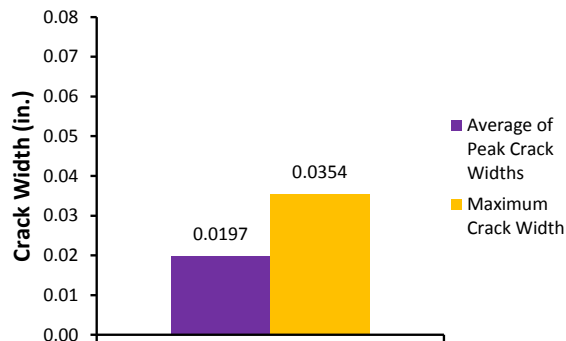
***Figure 5.98: Specimen 4.2 Crack Data***

Two transverse cracks were found on the specimen's top face. These cracks extended down the north and south faces of the specimen, although only one of the cracks was continuous over the entire width of the specimen. The epoxy used to seal the vertical side face portions of the transverse cracks was intact at the time of autopsy. Average width of the transverse cracks

was 0.02 inches. One short longitudinal crack was observed emanating from the south grout vent. The average width of this crack was 0.04 inches. Cracks extending from the anchorage pourbacks on both ends of the specimen toward the corbel re-entrant corner had formed during exposure. A small length of the cracks on the live end had been patched with mortar, indicating that they occurred during live load application. The remaining portion of the live end cracks and all of the dead end cracks formed after live load application. Some water was observed leaking from the unpatched portions of the cracks, indicating the presence of moisture inside the specimen (see Figure 5.97). Crack width data is shown in Figure 5.98, and the crack diagram is shown in Figure 5.102.

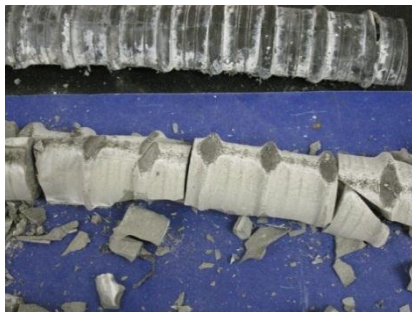
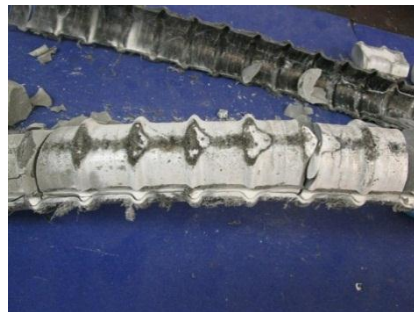
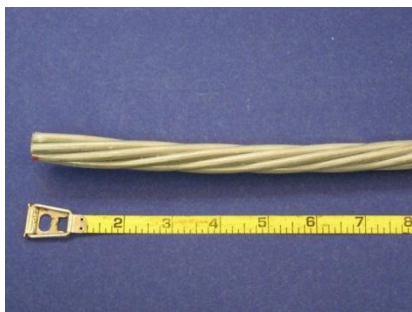
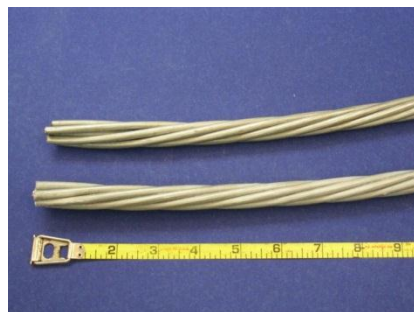
**Figure 5.101: Specimen 4.2 Main Autopsy Region Elements**

Both the north and south longitudinal bars experienced no corrosion and very little discoloration. Isolated stain spots were found in the vicinity of the stirrup tie locations, as shown in Figure 5.101. Overall, damage was comparable on both bars, and the extent of staining did not coincide with the locations of the specimen's surface cracks. Longitudinal bar corrosion ratings are shown in Figure 5.102 and summarized in Table 5.21.

Corrosion damage to the stirrups was mild. Discoloration and light surface corrosion were generally found in the vicinity of the stirrups' bend points and midspan of their horizontal regions. Almost all visible corrosion could be removed with a scouring pad. However, stirrup #5, shown in Figure 5.101, showed pitting over one interval at its center. The highest corrosion ratings were observed in the stirrups underneath the specimen's transverse surface cracks. Stirrup corrosion ratings are shown in Figure 5.102 and summarized in Table 5.21.

The north plastic duct showed a large amount of chalky white residue on its outer surface. This residue formed small swirls near the live end of the duct, suggesting that small pockets of moisture may have been present there. Patches of shiny white crystals were found inside the duct. Evidence of a large, continuous void was found on the inner top portion of the duct, extending from the live end of the duct to the splice at midspan. Smaller voids were observed on the dead end half of the duct. These appeared to be confined to the top ribs of the duct. Gouges were observed on the duct's bottom interior surface, suggesting that at least one strand had been bearing on the duct over its entire length. Deep scratches, amounting to approximately 10% of the duct's thickness, were seen on the top interior surface of the duct along almost its entire length. This damage was likely caused by the highly curved strands as they were threaded through the duct prior to stressing (see Figure 5.101).

transverse ribs, although some bubbling and discoloration was observed between voids, as shown in Figure 5.101. This suggests that pressure was not uniform on the top of the grout. Chloride content was 0.39% at midspan of the north grout and 0.32% at midspan of the south grout. Chloride content for north and south grouts is shown in Figure 5.102.

All strands in both the north and south tendons were nearly immaculate upon inspection. No corrosion or corrosion staining was found on the outer wires of any strand. The only discoloration observed was a light coating of white-gray grout residue (see Figure 5.101). This could easily be rubbed off over all intervals. When compared to a length of stainless steel strand which had been stored indoors for the duration of the exposure period, the strands extracted from the specimen showed no discernible difference in appearance, as shown in Figure 5.101. Small flecks of light surface corrosion were found at the dead end of every strand's inner wire, but this may have been due to water intrusion during the autopsy process. Strand corrosion ratings are shown in Figure 5.102 and summarized in Table 5.21.

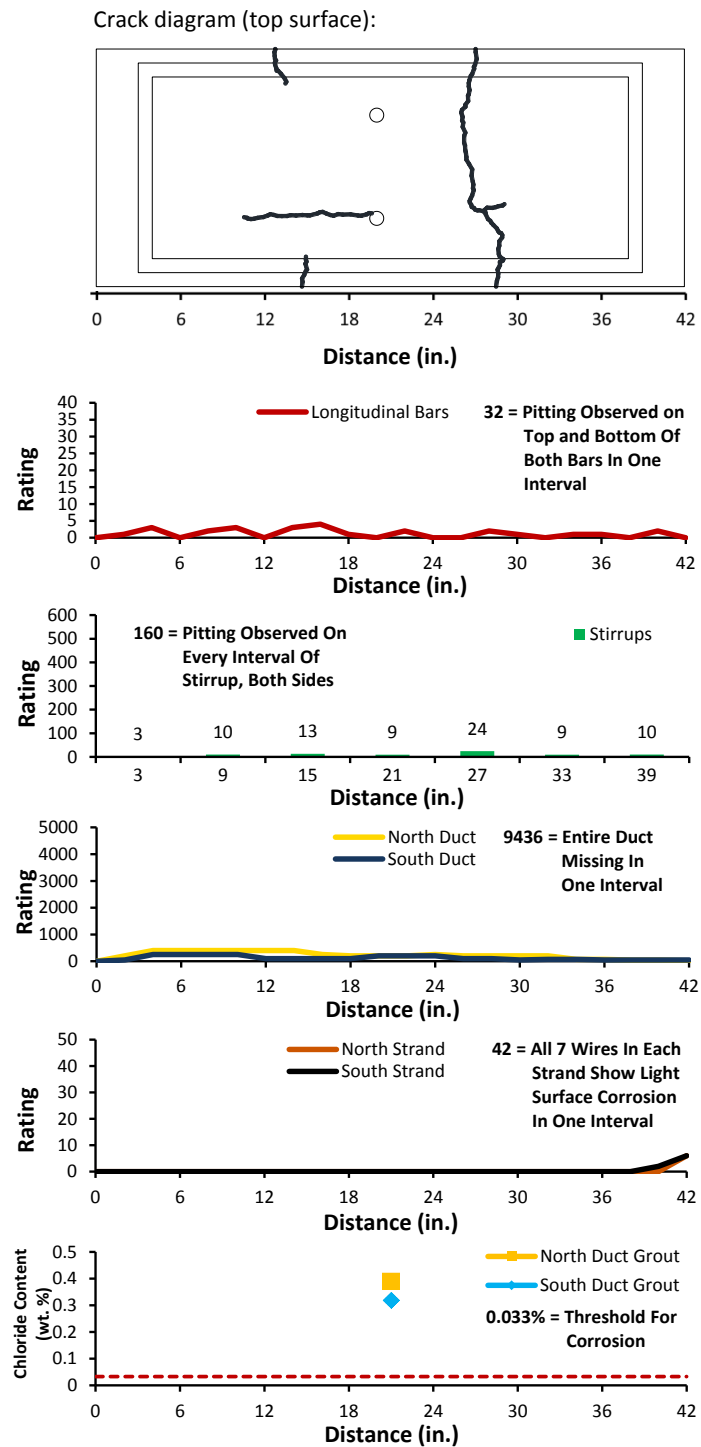
Figure 5.102: Specimen 4.2 Crack Map and Corrosion/Damage Rating Plots

Damage to the south duct was comparable to that of the north duct. Chalky white residue was found on the outside of the duct, and isolated spots of shiny white crystals were found inside. Evidence of a large void was observed on the live end half of the duct's top interior surface. This void extended from 2 inches from the live end of the duct to just past midspan (see Figure 5.101). Smaller voids were found on the dead end half of the duct. These voids appeared to be completely contained within the top ribs of the duct. Extensive scratching was present on the

entire interior of the duct, amounting to about 10% of the duct's thickness in places. No gouges were observed. The epoxy used to seal the grout vent at its intersection with the duct was somewhat separated from the duct surface. It is unknown whether this occurred during autopsy or during exposure. Duct corrosion ratings are shown in Figure 5.102 and summarized in Table 5.21.

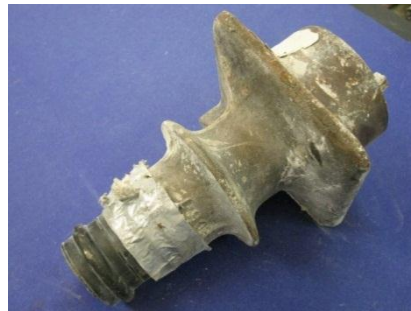
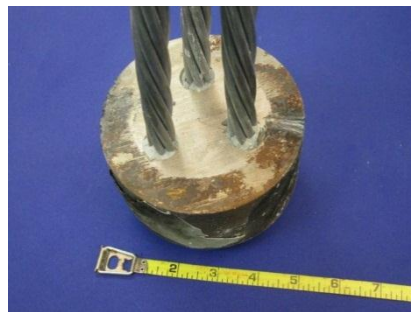
***Figure 5.103: Specimen 4.2 Anchorages and Anchor Heads***

The epoxy used to coat the exposed surfaces of both anchorages was partially intact on anchorages. Light to moderate surface corrosion was observed on the exposed surface of both bearing plates, tending to concentrate on the lower half of the bearing plates. Some pitting was observed on the bottom edge of the north bearing plate. The bottom edge of the south bearing plate had been cut off during autopsy, so no observations could be made there. Spots of light to moderate corrosion were found on the portions of the anchorages which were cast against concrete, tending to occur mostly on the underside of both bearing plates. The duct tape used to splice the ducts into the bearing plates was mostly intact. Only light discoloration was found on the anchorages beneath the duct tape. Moderate surface corrosion was found on the inner surface of both anchor heads, and light surface corrosion was present on much of their side and outer surfaces. North and south anchorages and anchor heads are shown in Figure 5.103.

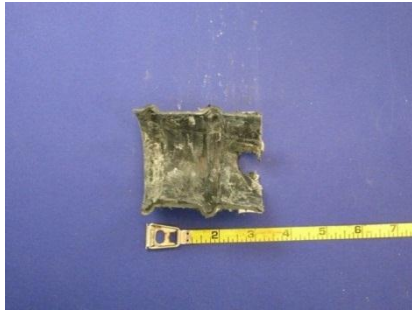
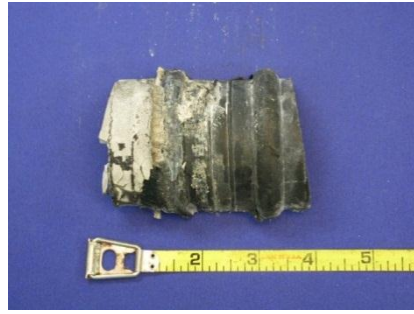
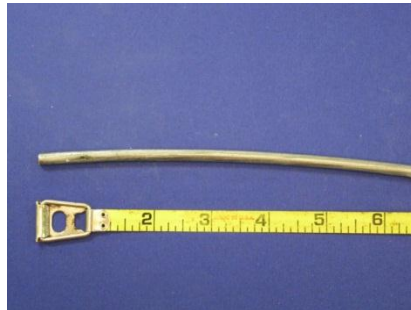
***Figure 5.104: Specimen 4.2 Anchorage Region Elements***

Only a short length of anchorage zone duct was recovered for both the north and south anchorages. These duct segments were also heavily damaged, limiting the conclusions which could be drawn. Chalky white residue was present on the outer surface of both ducts, and a shinier white residue was found inside the ducts. No evidence of voids was observed. The north duct showed substantial scratches on its bottom interior surface and some faint scratches on its top interior surface. The strands appeared to have damaged the duct as they were being threaded through prior to stressing. No scratches or gouges were observed within the south duct. North and south tendon ducts are shown in Figure 5.104. Anchorage zone duct corrosion ratings are shown in Figure 5.105 and summarized in Table 5.22.

The north and south anchorage zone strands were not in the same condition as those in the main autopsy region of the specimen. Discoloration was found on all strands in the region where wedges had been applied, both on the inner and outer wires of every strand. The only corrosion present on the anchorage zone strands was one small spot found on the end away from the anchor head on the inner wire of one south duct strand. All discoloration could be wiped away to reveal clean strand underneath. Typical strands, with and without wedges, are shown in Figure 5.104. Anchorage zone strand corrosion ratings are shown in Figure 5.105 and summarized in Table 5.22.

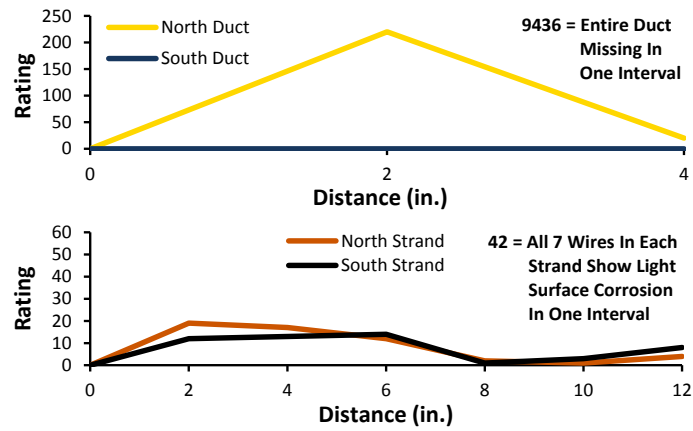
*Figure 5.105: Specimen 4.2 Anchorage Corrosion/Damage Ratings*

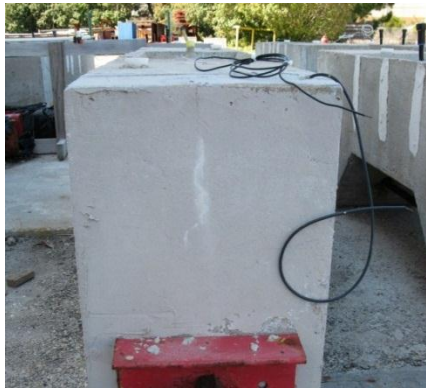
***Figure 5.107: Specimen 7.1, Efflorescence Around Crack on Live End***

Several transverse cracks were present on the top face of the specimen. Although only one crossed the full width of the specimen, five of the cracks extended down both the north and south faces. The epoxy used to seal the vertical portions of the transverse cracks was intact at the time of autopsy. Two of the transverse cracks were connected to longitudinal cracks which ran approximately 6 inches from the south face of the specimen. Average crack width for all surface cracks was 0.015 inches. Some separation was found at the joint between the live and dead end pourbacks and the surrounding concrete. Also, one vertical crack was found near the midpoint of the pourback on both ends of the specimen. Efflorescence was observed around both cracks, indicating the presence of moisture inside the anchorage zones of the specimen (see Figure 5.107). Crack width data is shown in Figure 5.108, and the crack diagram is shown in Figure 5.111.

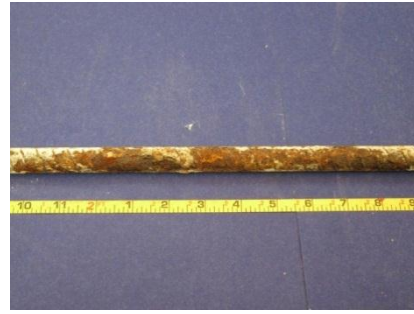
**Figure 5.110: Specimen 7.1 Main Autopsy Region Elements**

Damage to the epoxy-coated longitudinal bars was minor. Spots of discoloration and light surface corrosion were observed at the points where stirrups had been tied, as shown in Figure 5.110. All corrosion could be removed with a scouring pad. The south epoxy-coated bar was slightly more damaged than the north bar. The uncoated longitudinal bars showed moderate to severe corrosion damage. Spots of corrosion were observed along most of the bars' length. Near midspan, both bars were also pitted over several intervals (see Figure 5.110). The south uncoated bar was substantially more damaged than the north bar. It showed pitting on almost half of its total length. Longitudinal bar corrosion ratings are shown in Figure 5.111 and summarized in Table 5.23.

The stirrups were mildly damaged. Spots of discoloration and light corrosion were generally observed at the stirrups' bend points as well as locations where the uncoated bars were tied, as shown in Figure 5.110. It is possible that much of the discoloration at these locations was transported there from the uncoated bars. Most of the corrosion present could be removed with a scouring pad. However, localized moderate surface corrosion was found on 4 of the 7 stirrups on at least one interval. Stirrup #3 was the most damaged, with nonremovable corrosion visible on top of its horizontal region over several intervals. This stirrup was located directly beneath the specimen's largest transverse surface crack. Stirrup corrosion ratings are shown in Figure 5.111 and summarized in Table 5.23.

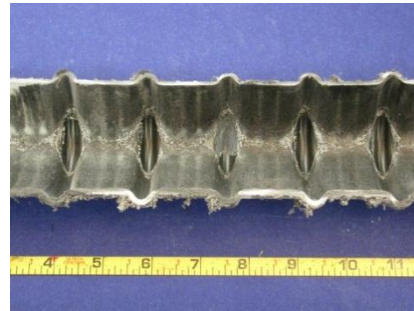
**Top of Duct**

The outside of the duct was extensively coated with chalky white residue. Some traces of corrosion products were found near the live end of the duct underneath the heat shrink sleeve. Inside, a shinier white residue was found, along with evidence of voids in the top inner ribs of the duct. These voids were uniform in size and did not appear to be continuous along the length of the duct (see Figure 5.110). Isolated light gouges were found on the duct's inner surface at various points along its length. It appeared that at least one strand had been bearing on the duct at those locations. Duct corrosion ratings are shown in Figure 5.111 and summarized in Table 5.23.

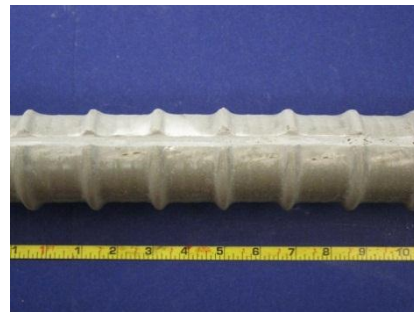
The specimen's grout was cracked every few inches along its length. These cracks were very faint, and no longitudinal cracks were observed. Voids which were approximately 1 inch wide were found along the top surface of the grout. These voids were confined by the upper ribs of the duct, but some small bubbles were also observed between ribs (see Figure 5.110). The bottom half of the grout was much smoother to the touch and much darker in color than the top half, as shown in Figure 5.110. This may indicate density variations within the grout. One strand was visible on the bottom surface of the grout at points along its length. Chloride contents were below the corrosion threshold along the length of the grout: 0.029% at midspan, and 0.030% and 0.027% at the live end and dead end couplers, respectively. Grout chloride content is shown in Figure 5.111. Because no breaches were found in the duct couplers, chlorides must have entered the tendon by some other means. Corrosion found on the anchorage components suggests that chlorides may have entered there. This is discussed in sections 5.2.10.6 and 5.2.10.7.

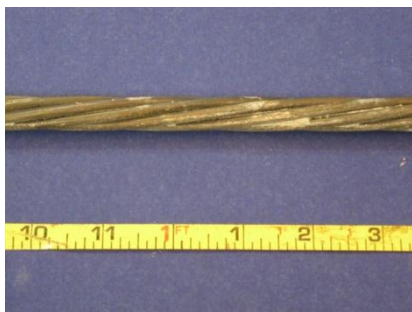
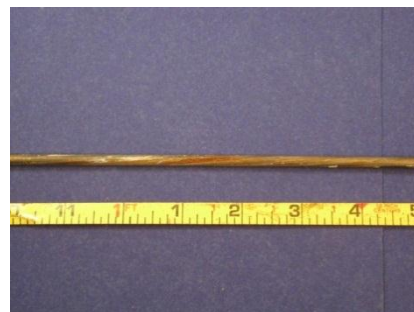
Corrosion damage to the strands was uniform and minor. The outer wires of each strand showed spots of discoloration and light surface corrosion over most intervals. All corrosion could be removed with a scouring pad (see Figure 5.110). The inner wire on each strand was somewhat more damaged, as shown in Figure 5.110. Corrosion which could not be removed was found in several intervals along each strand. Strand corrosion ratings are shown in Figure 5.111 and summarized in Table 5.23.

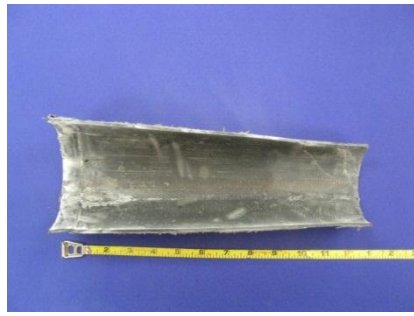
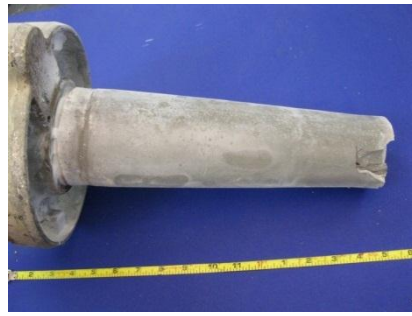
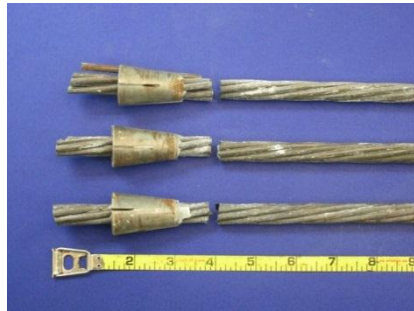
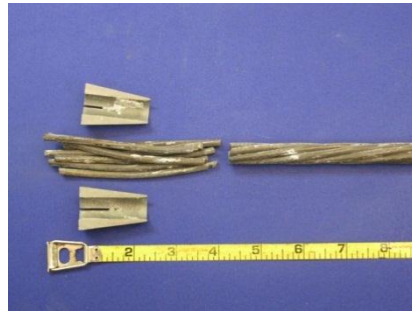
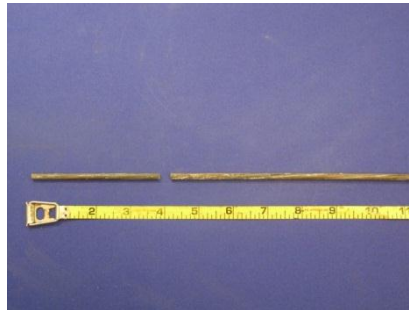
**Figure 5.115: Specimen 7.1 Dead End Anchorage Region Elements**

The trumpet was completely intact at the time of autopsy. Chalky white residue was observed on the outer surface of the trumpet. Some localized corrosion staining was observed near the bearing plate. Inside the trumpet, lines were visible in the shiny grout residue which suggested that the grout was cracked longitudinally there. The trumpet is pictured in Figure 5.115. Trumpet damage ratings are shown in Figure 5.118 and summarized in Table 5.24.

The dead end anchorage zone strands were somewhat damaged but overall in good condition. The outer wires of each strand showed spots of discoloration or light surface corrosion over most of their length. All corrosion could be scrubbed away with a scouring pad. The inner wires were more damaged, with light to moderate surface corrosion occurring over all intervals, as shown in Figure 5.115. On the inner wires of two strands, the heaviest corrosion occurred on the intervals which had been located inside the anchor head. Light to moderate surface corrosion was found on the exterior of all three wedges. The interior of each wedge was not damaged. A typical strand is shown with and without wedges in Figure 5.115. Dead end anchorage zone strand corrosion ratings are shown in Figure 5.118 and summarized in Table 5.24.

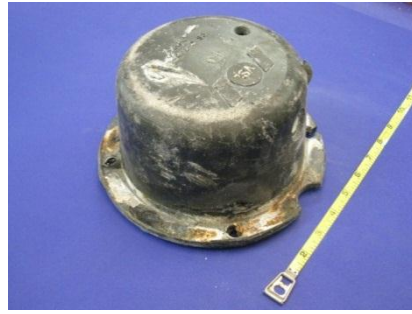
**Figure 5.116: Specimen 7.1 Live End Anchorage Cap Components**

The orientation of the components within the live end anchorage cap is shown in Figure 5.112. The grout cap was covered in white, chalky residue and showed moderate corrosion staining along its outer lip. Localized moderate corrosion and pitting were found on all surfaces of the retaining ring. The most severe damage occurred near the top of the ring. The insulation plate was lightly stained on both sides. Staining was most severe in the vicinity of its inner edge. The bearing plate showed widespread moderate corrosion and some localized pitting on the

surface it shared with the insulation plate. The corrosion near the middle of this outer surface was burnt orange in color, while the corrosion around the bearing plate's outer edge was a much darker red. The inboard side of the bearing plate had localized light to moderate surface corrosion, mostly occurring on its upper portion. Many small spots of light surface corrosion were observed on the outer surfaces of the anchor head, while moderate surface corrosion covered much of the surface which had rested on the bearing plate. A small "window" of moderate corrosion was found on the upper surface of the anchor head. This appeared to coincide with the location of small grout void there and may have been another chloride ingress point for the tendon. Anchorage cap components are shown in Figure 5.116.

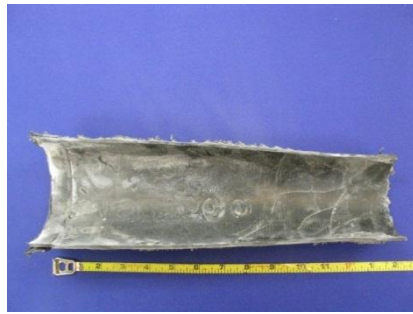
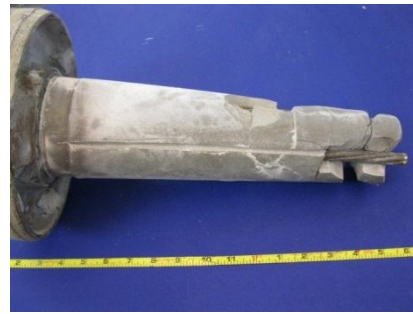
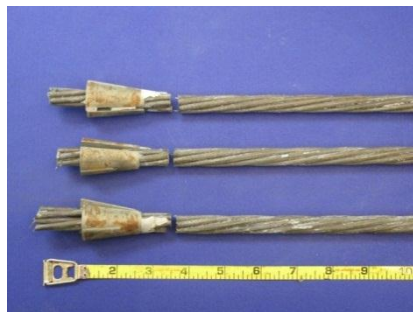
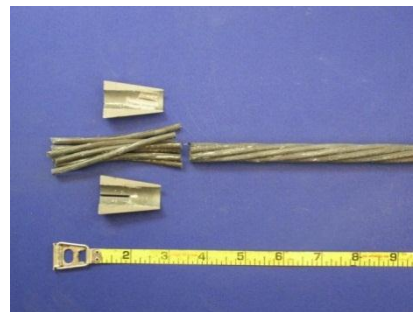
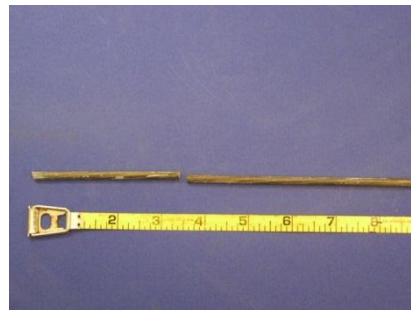
**Figure 5.117: Specimen 7.1 Live End Anchorage Region Elements**

The live end trumpet was similar in appearance to the dead end trumpet. Chalky white residue was found on its outer surface, along with small areas of corrosion staining on the portion of the trumpet which had been inside the bearing plate. Shiny white residue was present on the inner surfaces of the trumpet. Lines in this residue suggested that the grout may have been cracked there. The live end trumpet is pictured in Figure 5.117. Trumpet damage ratings are shown in Figure 5.118 and summarized in Table 5.24.

The live end anchorage strands were somewhat less damaged than the dead end strands. Discoloration spots were visible along many of the outer wires’ length in all three strands, as shown in Figure 5.117. Occasional spots of light surface corrosion were observed on the outer wires. These did not occur solely in the anchor head regions of each strand. The inner wires were more corroded. Localized light surface corrosion was present on all intervals (see Figure 5.117). With the exception of one interval on one of the outer wires, this corrosion could be removed with a scouring pad. All three wedges were substantially intact, although spots of moderate surface corrosion were found on their outer surfaces. Typical live end anchorage region strands, with and without wedges, are shown in Figure 5.117. Live end anchorage zone strand corrosion ratings are shown in Figure 5.118 and summarized in Table 5.24.

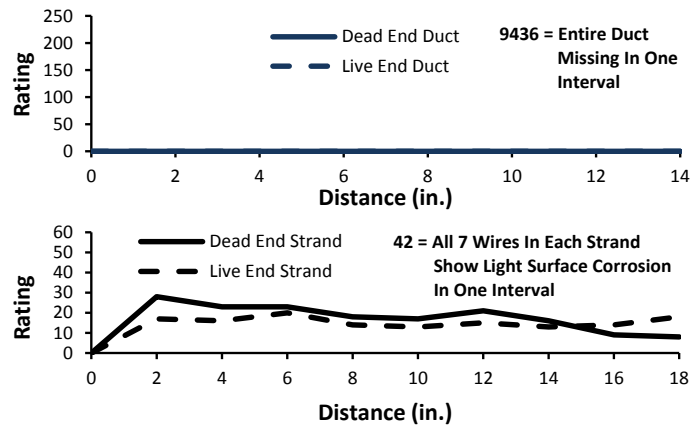
**Figure 5.118: Specimen 7.1 Anchorage Corrosion/Damage Ratings**

Damage to the dead end anchorage cap components was slightly more severe than the damage to the live end components. Trumpet damage was not severe enough to allow chloride ingress into the anchorage. Therefore, trumpet damage ratings will not be considered here. Strand corrosion ratings were slightly higher for the dead end strand on all but the two innermost intervals of the anchorage regions. Generalized corrosion for the live end strands was 5 units higher than that for the dead end strands. Given that damage was uniformly more severe for dead end anchorage components than for their live end counterparts, it is possible that the corrosion was affected by the saltwater spray applied to the dead end during the test period. The vertical cracks which displayed efflorescence also support this hypothesis, although the extent of efflorescence was similar on both ends of the specimen. Further, it appears that chlorides entered the tendon through the anchorage caps. Due to the similar appearance of the corroded “window” on both anchorage caps, the chlorides originated from the saltwater pond and not the dripper. From the anchorages, chlorides were able to traverse the entire tendon within the strand interstices, which resulted in the uniform corrosion ratings observed in the main autopsy region.

However, the difference in corrosion damage between the ends of the specimen was not drastic enough to conclude with certainty that exposure worsened the corrosion at the dead end. Note that the saltwater exposure system had not been operational for at least one year prior to autopsy.

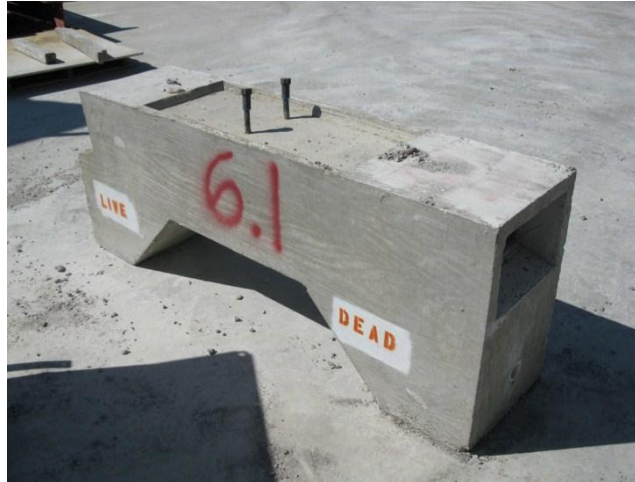
*Figure 5.119: Control Specimen Overall Appearance*

The beam was in near-immaculate condition at the time of autopsy, as shown in Figure 5.119. Some light scaling had taken place along the edges of the saltwater tray. Small surface air voids were visible on the north and south faces of the specimen, as well as within the saltwater tray. No cracks were observed at any location on the specimen, as it had never been stressed.

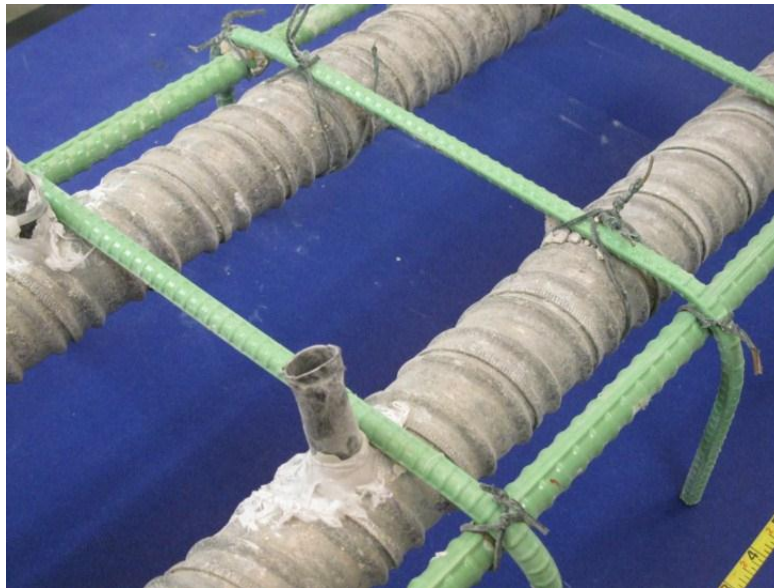
***Figure 5.120: Control Specimen Rebar Cage and Ducts***

None of the epoxy-coated bars or stirrups within the specimen showed any signs of corrosion whatsoever (see Figure 5.120). Longitudinal bar and stirrup corrosion ratings are shown in Figure 5.121 and summarized in Table 5.25.

The outside of both the north and south ducts was covered in a dull gray residue, as seen in Figure 5.120. No corrosion damage was found on the outer surfaces of either duct. Because the ducts had not been grouted, their inner surfaces were exposed to air for the entire exposure period. As this was not consistent with conditions inside the ducts of the exposure specimens, the inside surfaces of the control specimen were not evaluated for corrosion. Duct corrosion ratings are shown in Figure 5.121 and summarized in Table 5.25.

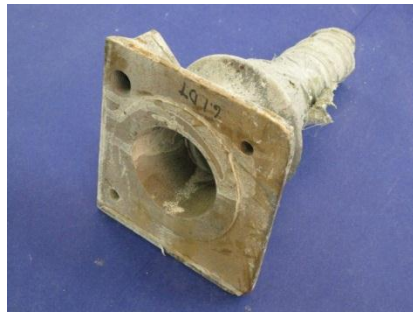
**North Bearing Plate**

A uniform layer of light surface corrosion was present on the exposed surface of the bearing plates. Localized light to moderate surface corrosion was found along the outside edges of the bearing plates, as well as on the portions of the anchorages around which concrete had been cast. The duct tape used to make the connection between the ducts and bearing plates was intact. A small amount of light surface corrosion was found beneath the duct tape on both bearing plates. North and south anchorages are shown in Figure 5.122.

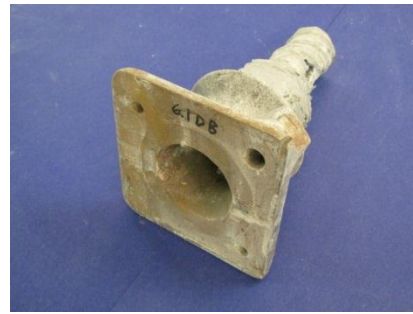
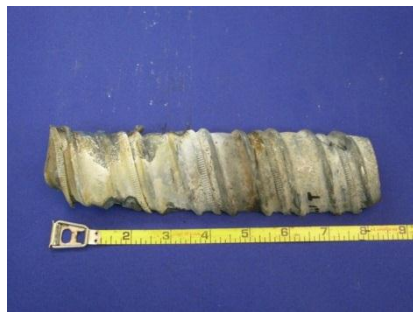
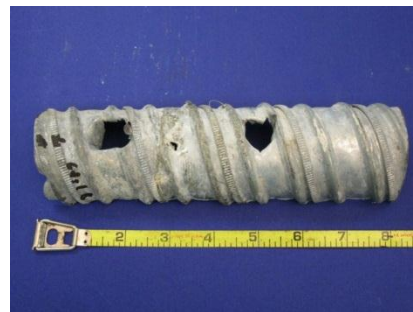
**Figure 5.122: Control Specimen Anchorages and Ducts**

Some spots of discoloration were present on the outside of the north and south ducts in the area where the duct tape had been applied. This is shown in Figure 5.122. The inner surfaces of the ducts were not evaluated because they had spent several years exposed to air. Anchorage zone duct corrosion ratings are shown in Figure 5.123 and summarized in Table 5.26.
